BASRAH INTERNATIONAL AIRPORT –  
TERMINAL AND TOWER  
RENOVATION  
BASRAH, IRAQ

**PROJECT NUMBER SIGIR-PA-06-049**

SUBJECT: Report on Project Assessment of the Basrah International Airport Terminal  
Tower Renovation, Basrah, Iraq (Report Number SIGIR-PA-06-049)

## Basrah International Airport – Terminal and Tower Renovation, Basrah, Iraq

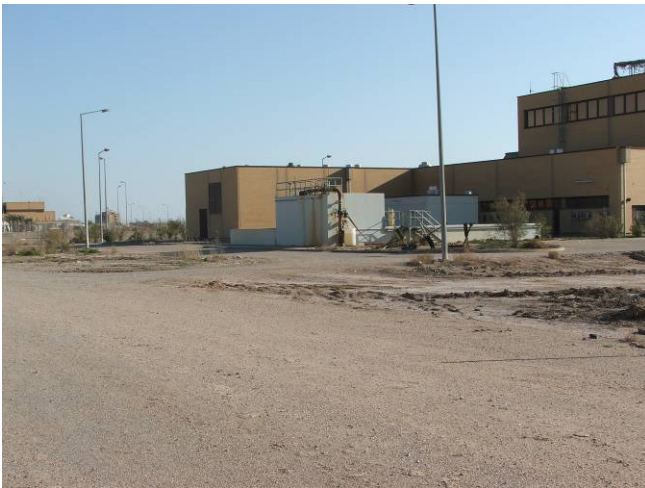
Water is supplied to above ground storage tanks at BIA from the sweet water canal via a pumping station and pipelines. BIA had an existing water treatment facility (original capacity of 220 cubic meters per hour ( $\text{m}^3/\text{h}$ )), which included clarification dosed with aluminum sulfate (alum) followed by filtration and chemical disinfection by chlorination. Dosing by alum, ferric chloride, phosphate, and soda takes place at various stages of treatment to achieve water conditioning and pH control. Treated water then passes through Reverse Osmosis (RO) filters before it is pumped into the supply distribution system and “process” water system. There is a separate fire suppression system which includes electric and diesel operated pumps and

Site Photo 3 shows the exterior of the water treatment facility and Site Photo 4 shows the Reverse Osmosis filters located inside the water treatment facility.

**Site Photo 3. Exterior view of water treatment facility**

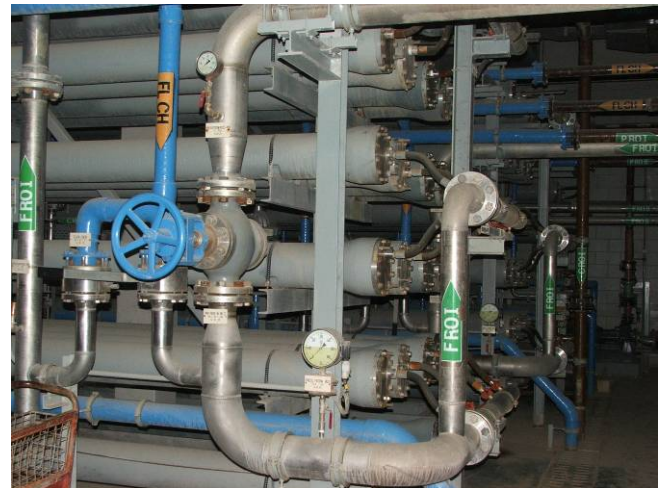
**Site Photo 4. Reverse Osmosis filters**

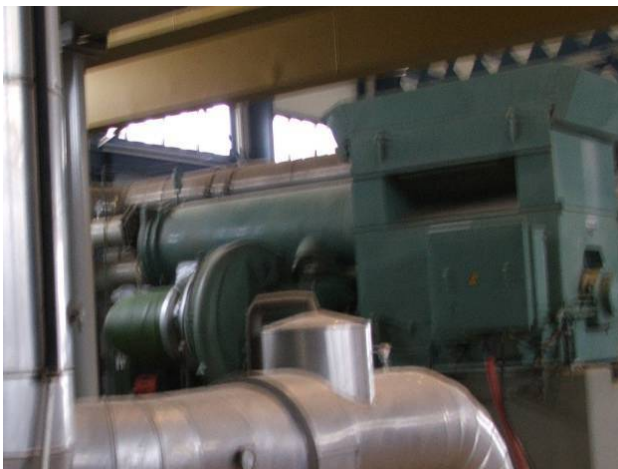
Site Photo 5 shows one of the three chiller units located inside the plant facility and Site Photo 6 shows the three pairs of cooling towers located adjacent to the plant facility.

**Site Photo 5. Chiller unit inside plant facility**

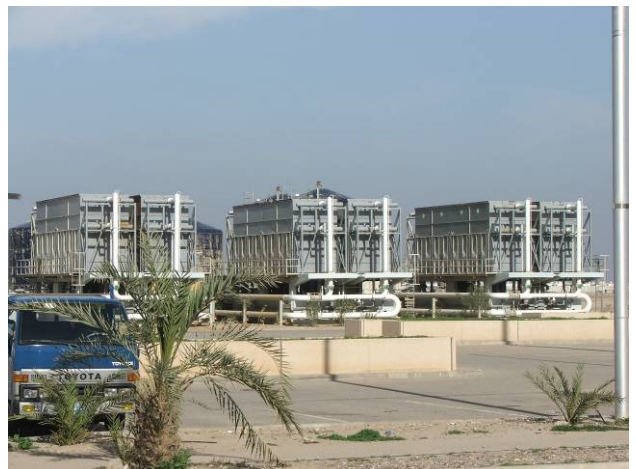
**Site Photo 6. Three pairs of the cooling towers located adjacent to the plant facility**

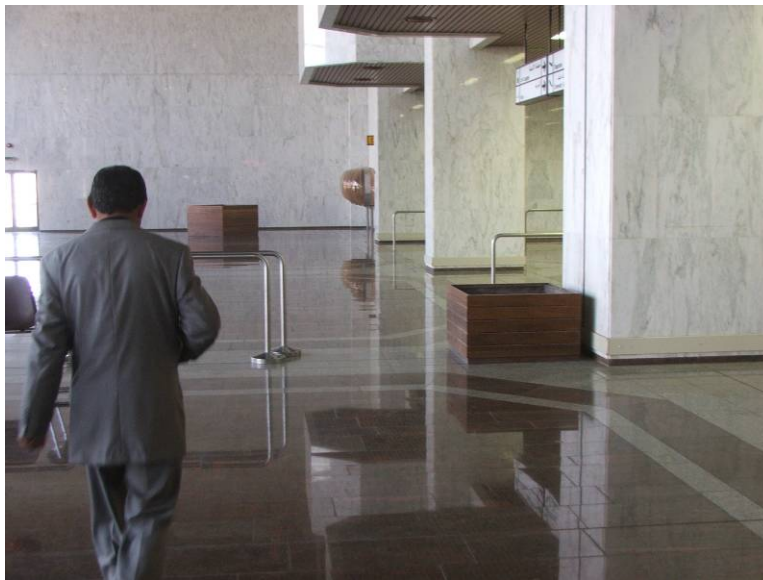
A walkthrough of the passenger terminal was conducted to determine its general condition. The passenger terminal lobby, ticket counters, waiting area, baggage claim, elevators, escalators, and administrative areas, were visited. Overall, the areas appeared clean and operational. Site Photo 7 shows the lobby of the passenger terminal and Site Photo 8 shows the passenger waiting areas.

**Site Photo 7. Passenger terminal lobby**

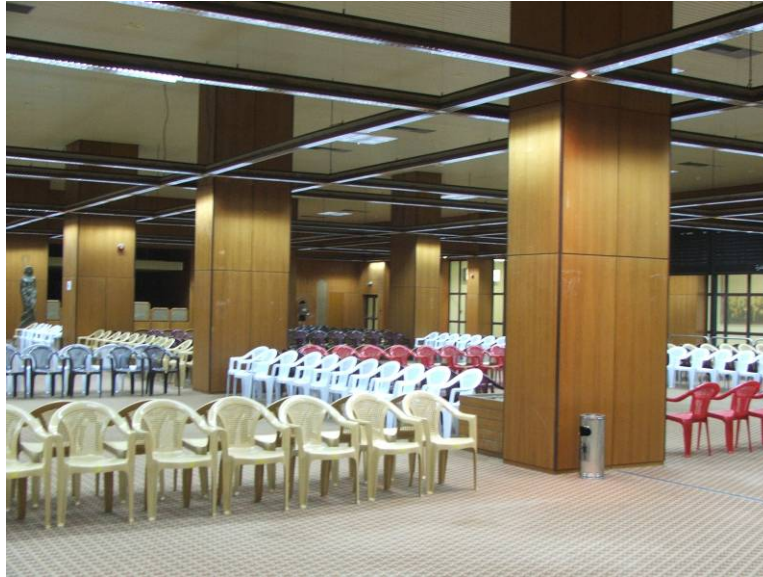
**Site Photo 8. Passenger terminal waiting area**

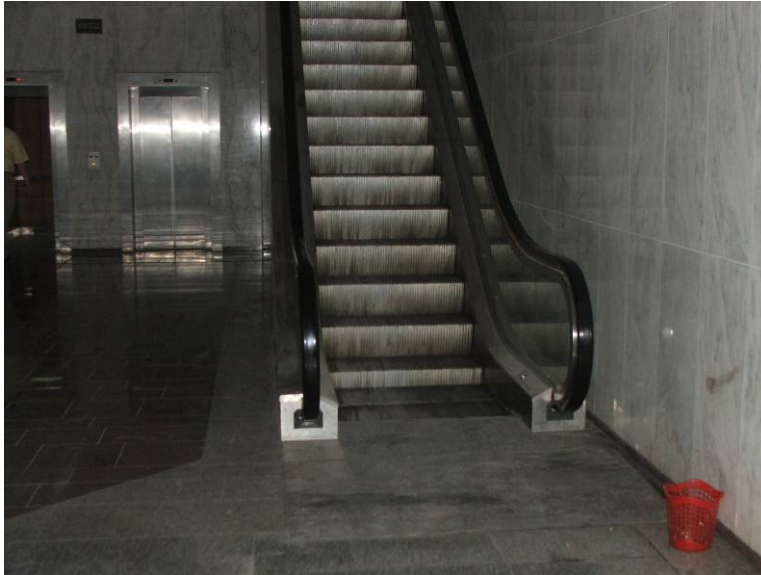
One elevator and one escalator were visited during the site assessment. Both were observed to be operational. Site Photo 9 shows one of the escalators and two elevators. The contractor certified the work that was completed, although the contractor did not certify the complete operation of the elevators.

**Site Photo 9. Escalator and two elevators (left) at passenger terminal**

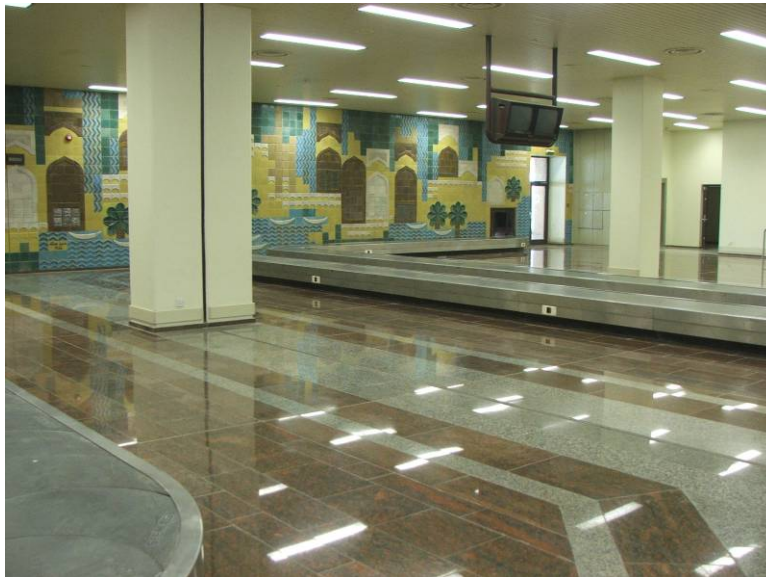
The baggage claim conveyors were located in an area which required cleaning and painting. The baggage claim conveyors appeared to be clean and functional, although the operation was not verified during the assessment. Site Photo 10 shows the condition of the baggage claim area during the assessment.

**Site Photo 10. Baggage claim area with conveyors**

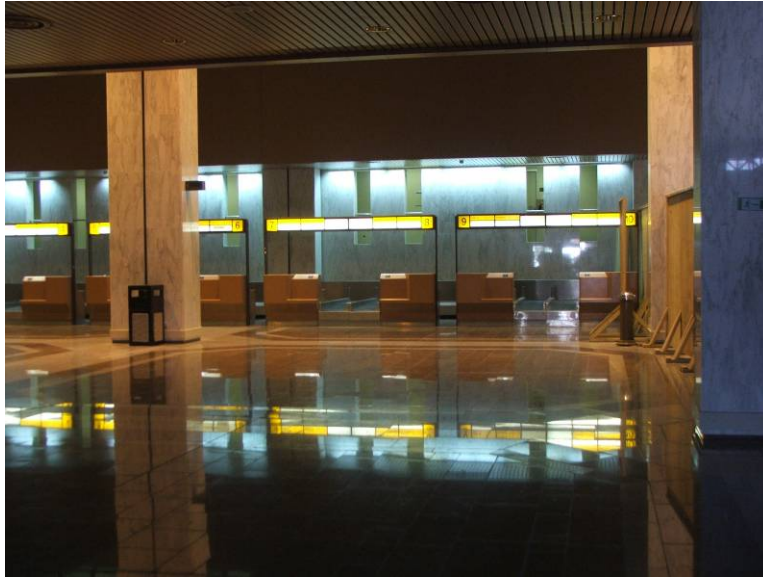
The contract and modification required the repair of ten domestic travel ticket counters, baggage scales, and conveyors. The domestic travel ticket counter area was observed during the assessment and appeared to be recently renovated. All lights were operational, the flooring was clean, and the ticket counter areas were well cleaned and appeared operational. Site Photo 11 shows the ticket counter area located inside the airport passenger terminal.

**Site Photo 11. Passenger terminal ticketing area**

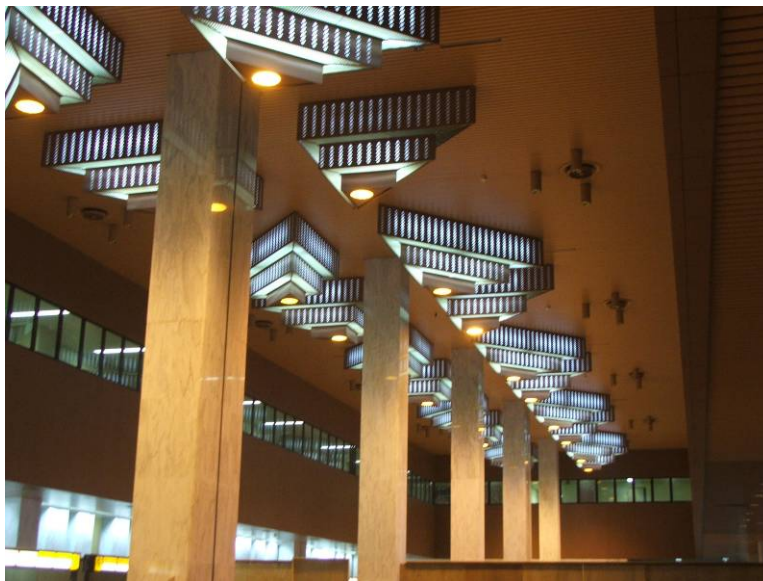
The contract required the repair or replacement of electrical lighting on the 1<sup>st</sup> and 2<sup>nd</sup> floor of the passenger terminal. Ceiling lights in the ticketing area as well as the 1<sup>st</sup> and 2<sup>nd</sup> floor administrative area were observed to be operational at the time of the site visit. Site Photo 12 shows the operational lighting in the ticketing area of the passenger terminal.

**Site Photo 12. Operational lighting in ticket area of passenger terminal**

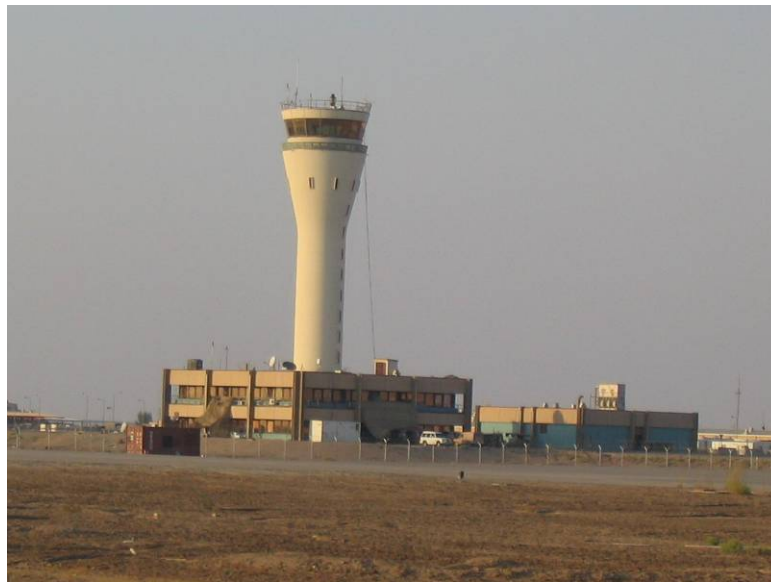
**Site Photo 13. Air Traffic Control tower (Courtesy of USACE)**

The original “defective” cooling towers were not observed on site. The ATC HVAC system was not operating at the time of the site assessment because processed water required for operation was not available. The USACE QAR stated the system requires pH balanced “processed” water generated at the BIA water treatment facility. The water treatment facility was not operational and was not producing and supplying the required processed water. The processed water system was temporarily activated in order to produce and supply processed water for the testing and commissioning of the HVAC units.

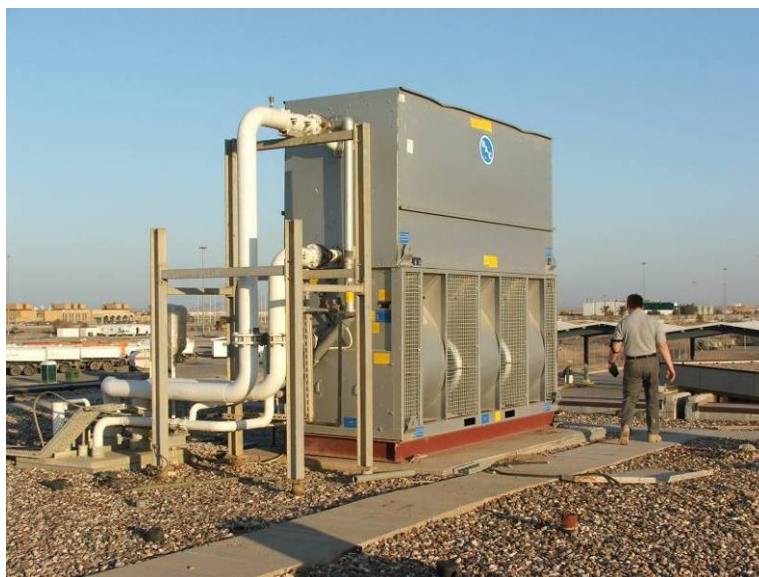
The contract required the removal of existing cooling towers and the supply and installation of new cooling towers, compressors, and chiller control panels. At the time of the assessment, one Baltimore Air Coil unit was observed installed on the roof of the tower administration building, located adjacent to the ATC. The unit was listed as model number VXI-50-3 with serial numbers H05-0950. The electrical

controls and piping appeared to complete. This unit was a direct replacement (same model number) of the previous existing cooling tower.

**Site Photo 14. Roof mounted cooling tower located at ATC administration building**

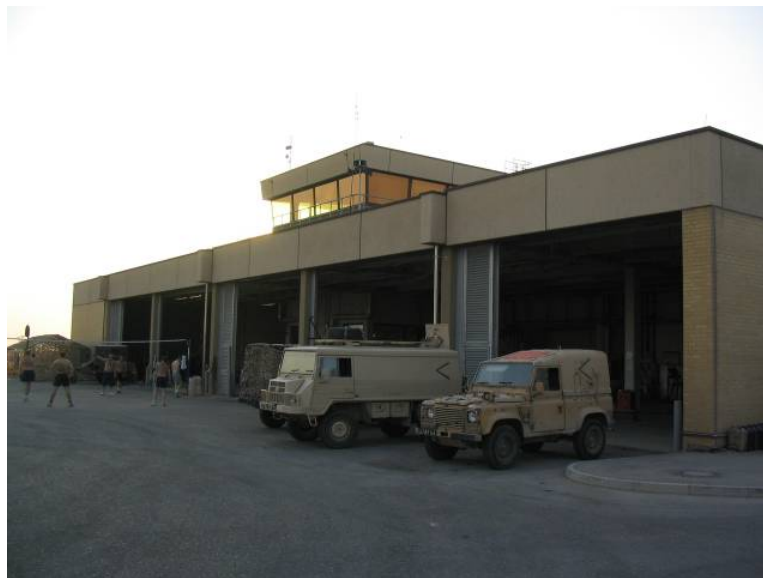
**Site Photo 15. Exterior front of fire station (Courtesy of USACE)**

The electrical controls and piping appeared to complete. The units were a direct replacement (same model number) as the previous existing cooling towers. The original “defective” cooling towers were not observed on site. The fire station HVAC system was not operating at the time of the site assessment because processed water required for operation was not available. As with the HVAC system at the ATC, the USACE QAR stated the system requires pH balanced “processed” water generated at the BIA water treatment facility. The water treatment facility was not operational and was not producing and supplying the required processed water. The processed water system was temporarily activated in order to produce and supply processed water for the testing and commissioning of the HVAC units.

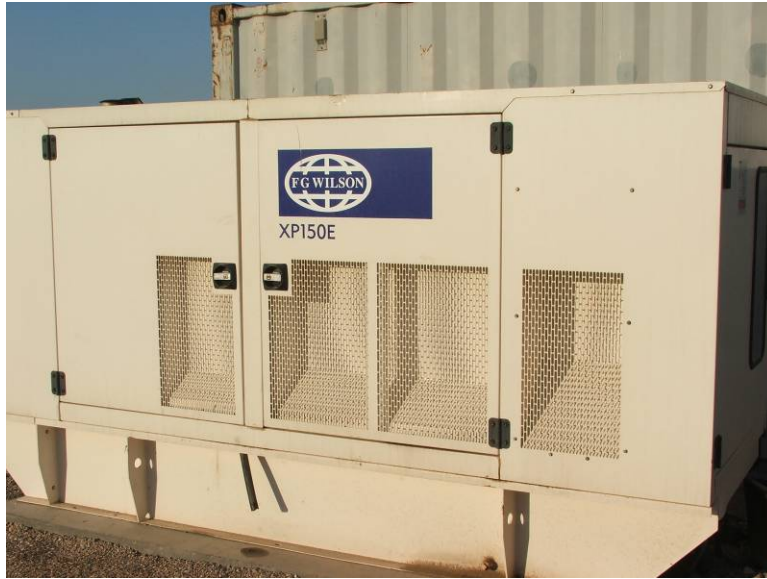
Site Photo 15 shows the exterior front of the fire station and Site Photo 16 shows the exterior shell of the generator set. Site Photo 17 shows the exterior located HVAC cooling towers.

**Site Photo 16. Generator set located at the fire station**

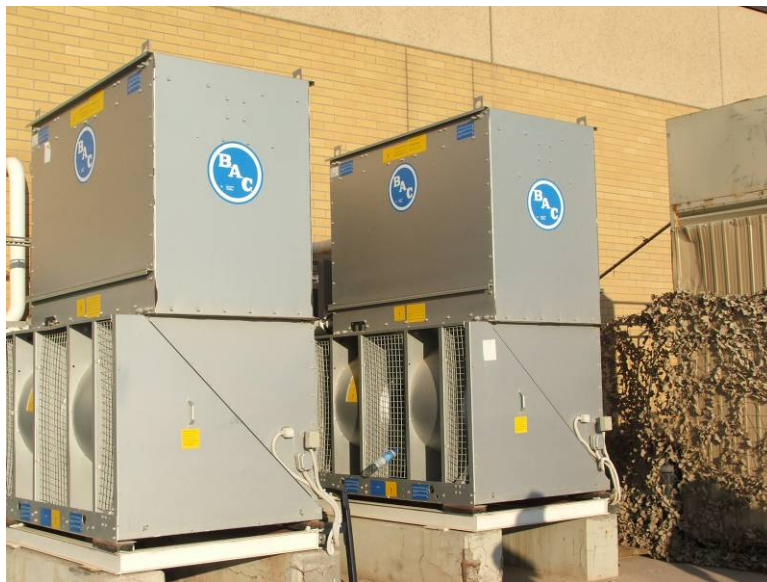
In addition, the contract required the removal of existing cooling towers and the supply and installation of new cooling towers, compressors, and chiller control panels. At the time of the assessment, two Baltimore Air Coil units were observed installed behind the fire station, mounted on existing concrete mounts. The two units were listed as model number VXI-18-2X with serial numbers H05-0948 and H05-0949.

**Site Photo 17. HVAC cooling towers located at fire station**

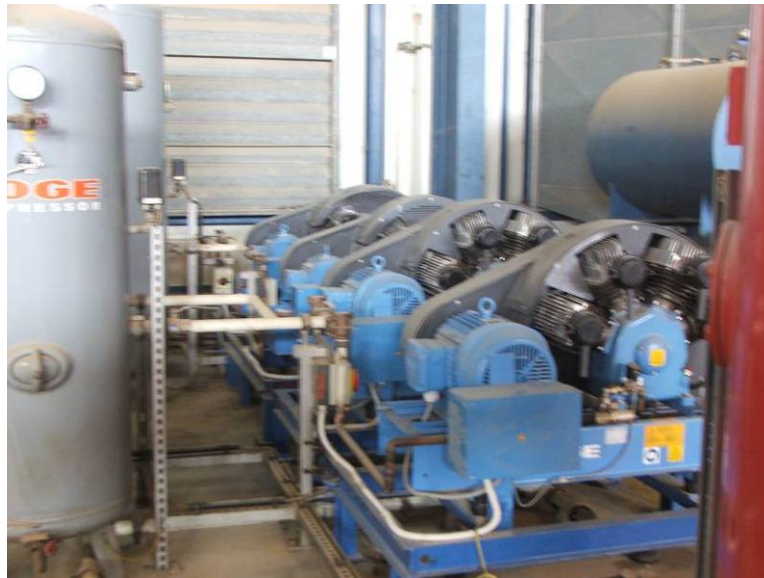
The contract required the overhaul and warranty of three-1700 ton chiller and six cooling towers, inspection, maintenance, and calibration of all primary/secondary chilled water and condenser systems and pumps, supply and installation of new air compressors, and inspection, maintenance, and commission of one boiler unit. Review of USACE project documents show the systems were renovated and commissioned 23 August 2005 and the turnover document signed 22 May 2006. During the site assessment, all systems were observed intact and appeared that maintenance activities were not on-going. New compressor pumps were observed installed in the plant facility.

Operation of the chillers, cooling towers, pumps, compressors, and boiler units could not be verified during the site visit because processed water required for operation was not available. The USACE QAR stated the system requires pH balanced “processed” water generated at the BIA water treatment facility. The water treatment facility was not operational and was not producing and supplying the required processed water. The processed water system was temporarily activated in order to produce and supply processed water for the testing and commissioning of the HVAC units. In addition, the boiler unit operates on diesel fuel. The fuel tanks are located adjacent to the plant facility, but it was reported that the fuel pumps were not operational.

**Site Photo 18. Air compressor units located at plant facility**

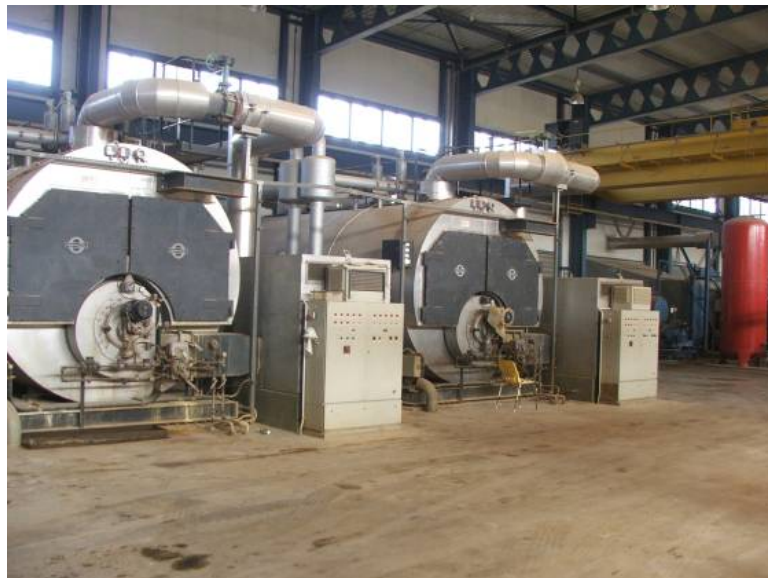
**Site Photo 19. Boiler units located at plant facility**
